# The Ultraviolet Detection of Corona Discharge in Power Transmission Lines

## ABSTRACT

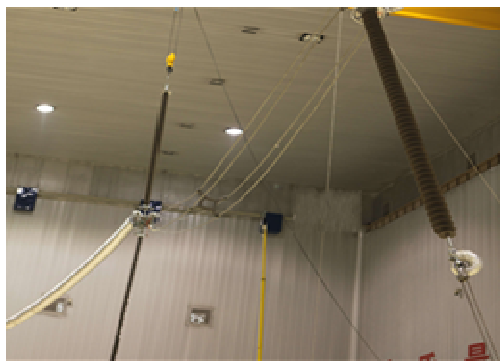
Figure 1. Picture of test model.

The experiment was carried out in a shielding hall with a size of  $66\text{ m} \times 30\text{ m} \times 18\text{ m}$ , and the test model was  $4 \times \text{LGJ300/40}$ , bundle space was 45 cm, height was 6.8 m, the model picture was showed in **Figure 1**. And the temperature was  $8.4^\circ\text{C} \sim 10.8^\circ\text{C}$ , relative humidity was 35%~43%.

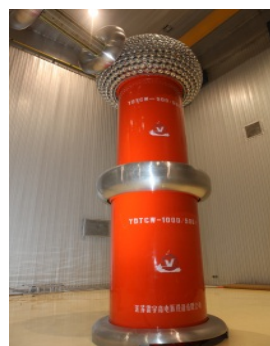
Figure 3. 1000kV transformer.

The UV imager with type of DayCor SuperB was showed in **Figure 2**. And the 50 Hz source with maximum of 1000 kV and 1000 kVA was showed in **Figure 3**.

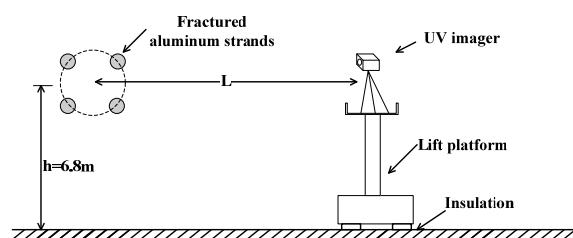
Figure 4. Measurement system schematic diagram.

And the measurement system schematic diagram was showed in **Figure 4**.

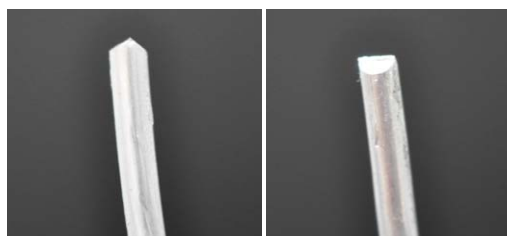
Figure 5. The top of the fractured aluminum strands.

The fractured aluminum strands (see **Figure 5**), was set at one of the LGJ300/40 conductor, with different length (see **Figure 6**).

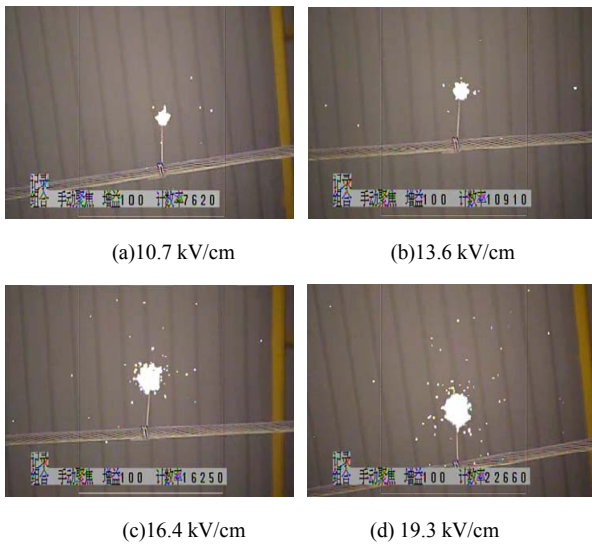
With the different influence factor applied on the strands, the corona phenomenon was detected by the UV imager. Limited by the paper length, one of them was showed in Figure 7.

We noticed in Figure 7 that the photon counting rate would increase with the rise of the applied voltage, such as applied voltage was 150 kV ( with conductor surface electric field is 10.7 kV/cm) while the photon counting was 7620, with the voltage increased to 270 kV ( with field 19.3 kV/cm) the photon counting rise at 22660.

Figure 7. Corona discharge at the top of fractured strand with different voltage applied (length of strand is 10cm, detection distance is 9 m, UV gain is 100).

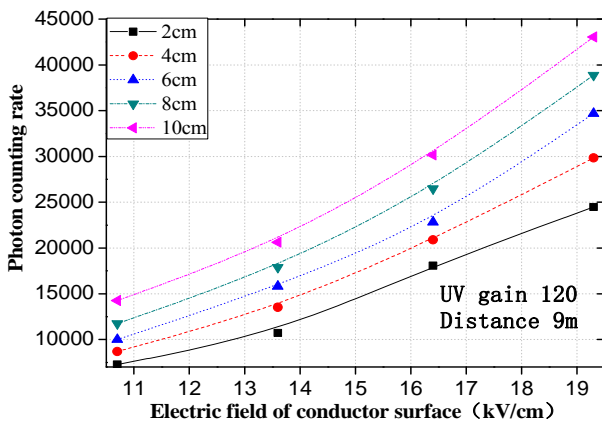
Figure 8. Influence of electric field.

With the applied voltage of 150kV, 190kV, 230kV, 270kV, the electric field was 10.7kV/cm, 13.6kV/cm, 16.4kV/cm, 19.3kV/cm, respectively, one part of result of experiment was show in Figure 8.

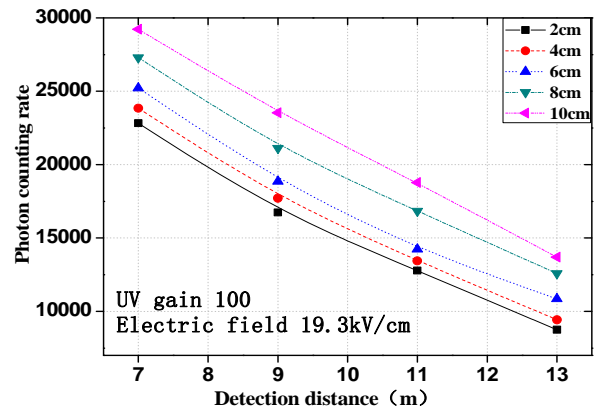
Figure 9. Influence of detection distance.

With the different detection distance of 7 m, 9 m, 11 m, 13 m, the results were partly showed in Figure 9.

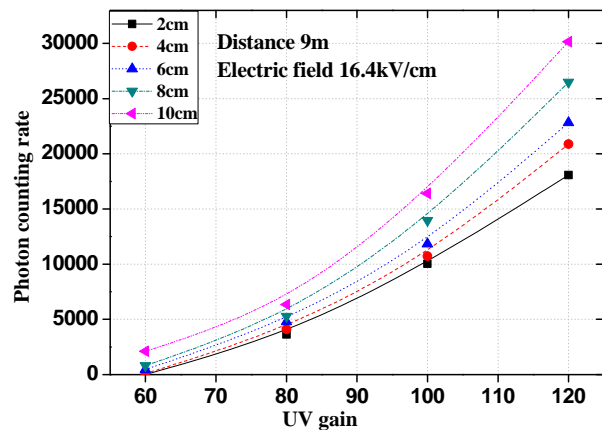
Figure 10. Influence of UV gain.

With the different UV gain was set in the experiment, the results were partly showed in Figure 10. However, the UV gain character is most related to the signal processing module of the UV imager designer, so it may different from other UV imager.

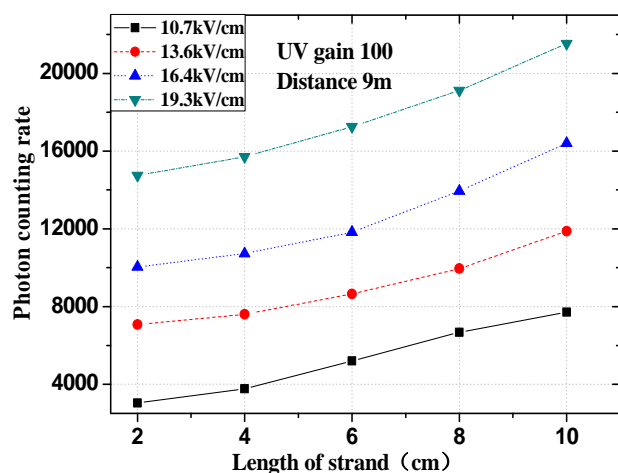
Figure 11. Influence of strand length.

With the different length of strand applied on the conductor, the results were partly showed in Figure 11.
